NEON TRANSFORMER ELECTRIC ARCS AS VIABLE IGNITION MECHANISMS FOR WOOD STRUCTURAL MEMBERS

Wendell C. Hull, Ph.D. Eng. Sci, CFEI, CVFEI

RESTAURANT FIRE INVOLVING NEON TRANSFORMERS

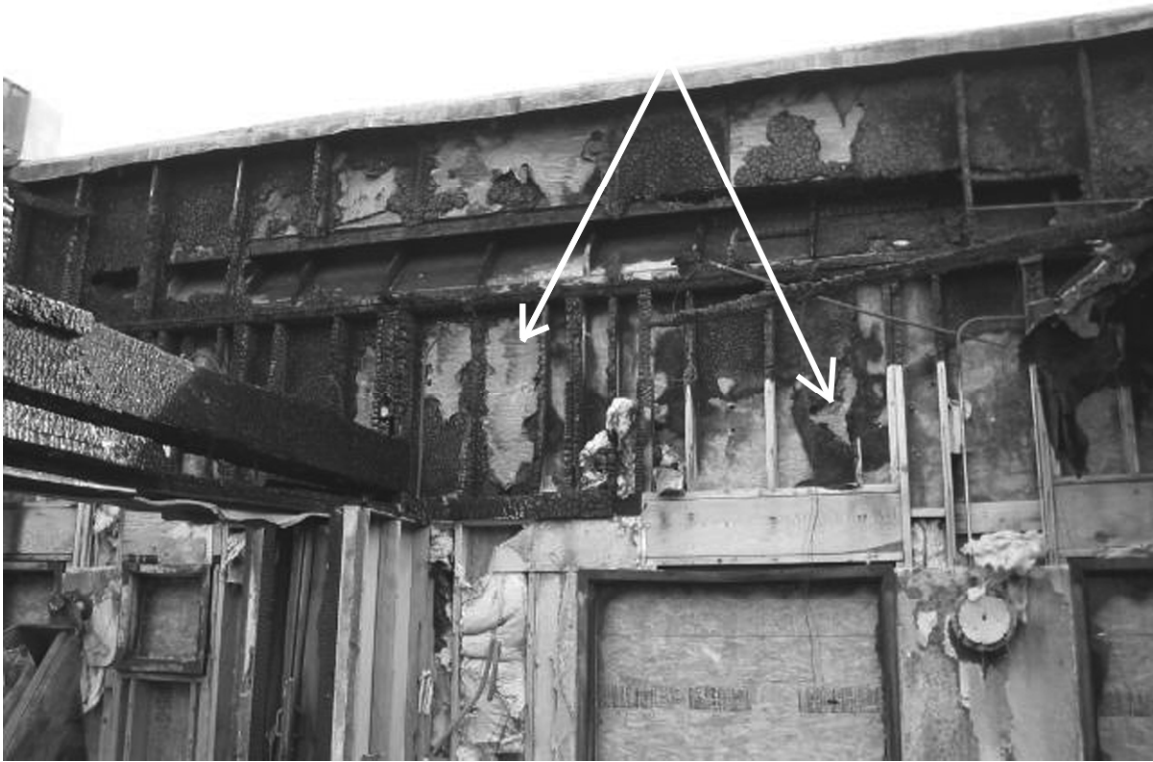
During their investigation, the fire department recovered two neon transformers from the southeast room of the restaurant. One of the neon transformers was found on the floor near the southeast corner of the room close to the east wall, while the other remained attached to the east wall just below roof level and about 20 feet from the southeast corner of the building. Their investigation led them to conclude that the area of origin of the fire was in this southeast room where they identified two V-shaped burn patterns on the east wall that represented the lowest burn areas in the building (see Figure 1).

Figure 1 - Two v-patterns in area of origin

Further investigation indicated the second larger V-pattern (see Figure 1), which was approximately 19 feet from the south corner of the east wall, was primarily caused by the asphalt which ran out of the neon transformer that had remained attached to the wall, but had tipped on its side, spilling the asphalt down the wall during the fire.

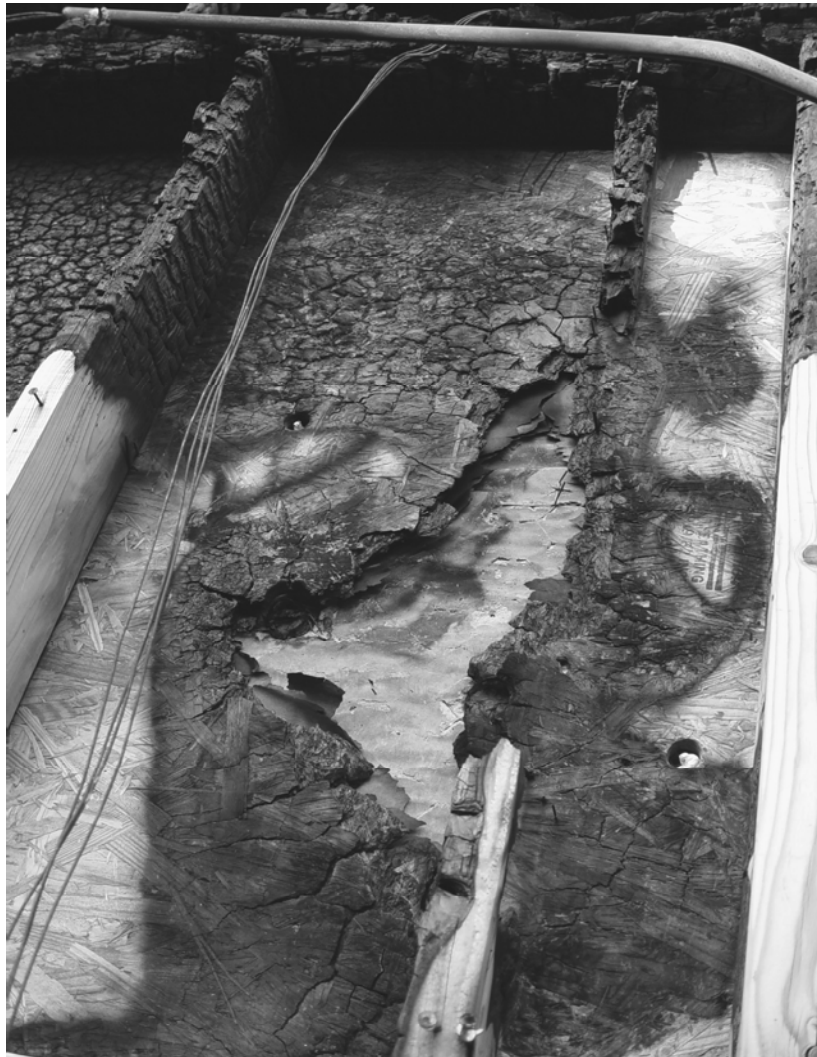
Investigation concluded that the fire patterns indicated that the point of origin of the fire was at the V-pattern which was approximately 13 feet from the southeast corner of the building, where two of the secondary output high voltage GTO wires from the neon transformers and their aluminum flexible conduits, would have been located after they were disconnected and pushed back into the wall from outside the building.

Close inspection of the V-pattern at the point of origin indicated burn-through of the OSB on the inside surface of the exterior wall and scorching of the stucco, all the way through the wall. Signs of scorching were observed on the internal and external surfaces of the stucco at this location (see Figure 2 and Figure 3). Additional photographs are available at www.wendellhull.com.

Figure 2 - Stucco scorching inside at point of origin

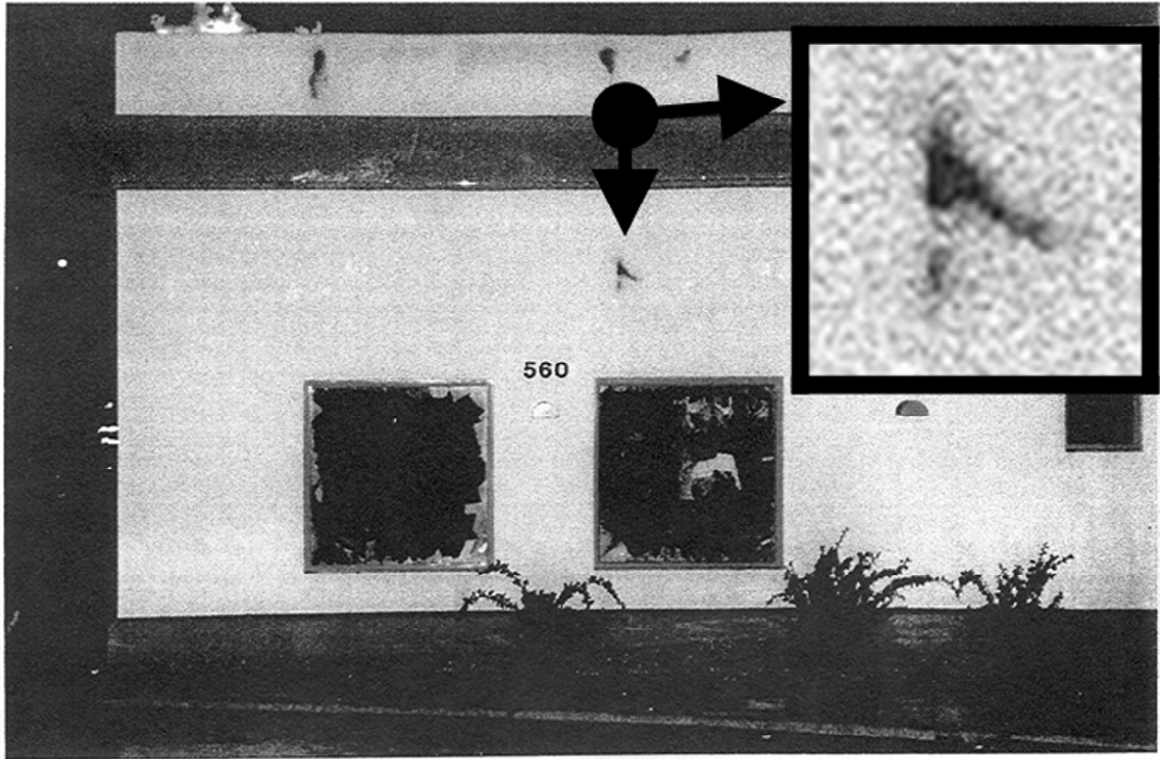
Figure 3 - Stucco scorching outside at point of origin

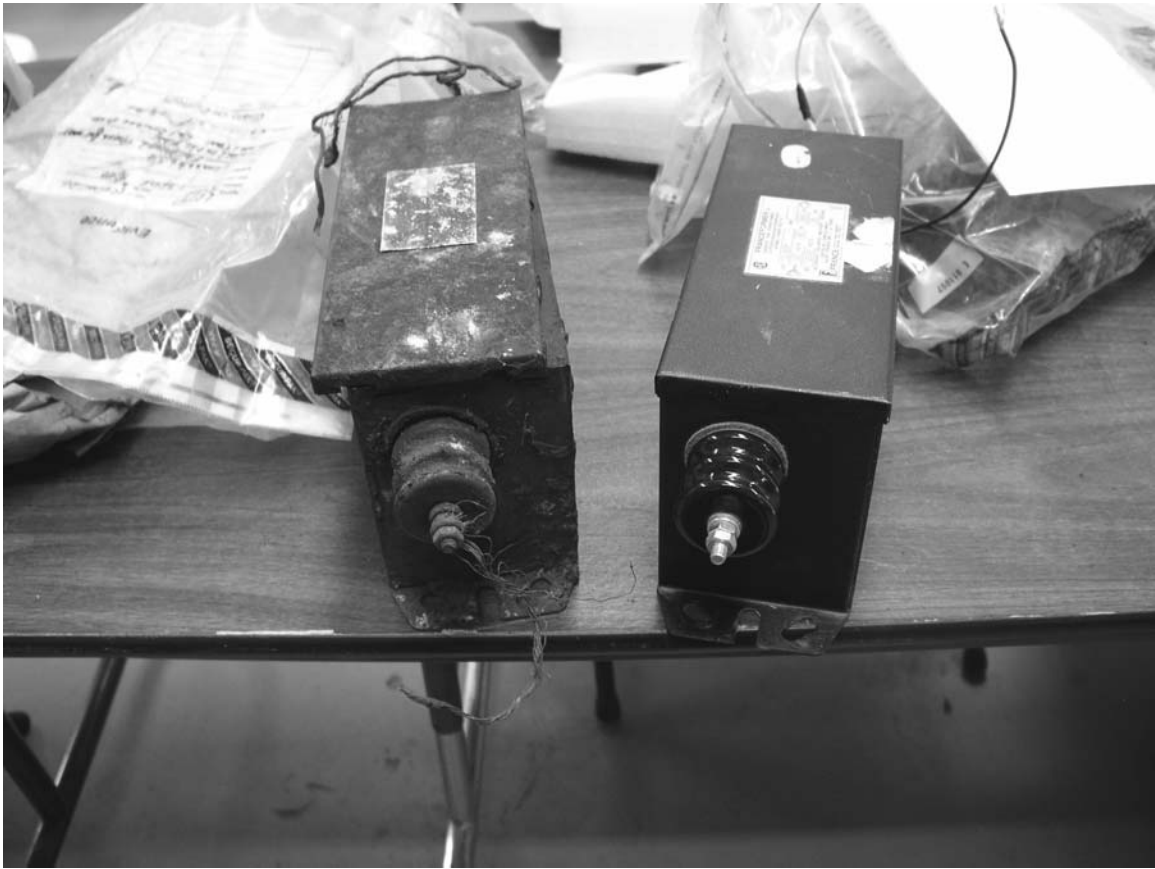
A photograph of one of the recovered neon transformers from the subject fire and an exemplar new transformer is shown in Figure 5. Typical neon sign transformers range in size from approximately 3"x 6" x 8" to 5" x 8" x 12" and weigh up to about 25 pounds. Part of their weight is associated with the asphalt with which they are filled. The asphalt serves as an insulator, a heat sink, and for the purpose of muffling noise produced by the transformer windings.

Figure 5 - Recovered and new neon transformers

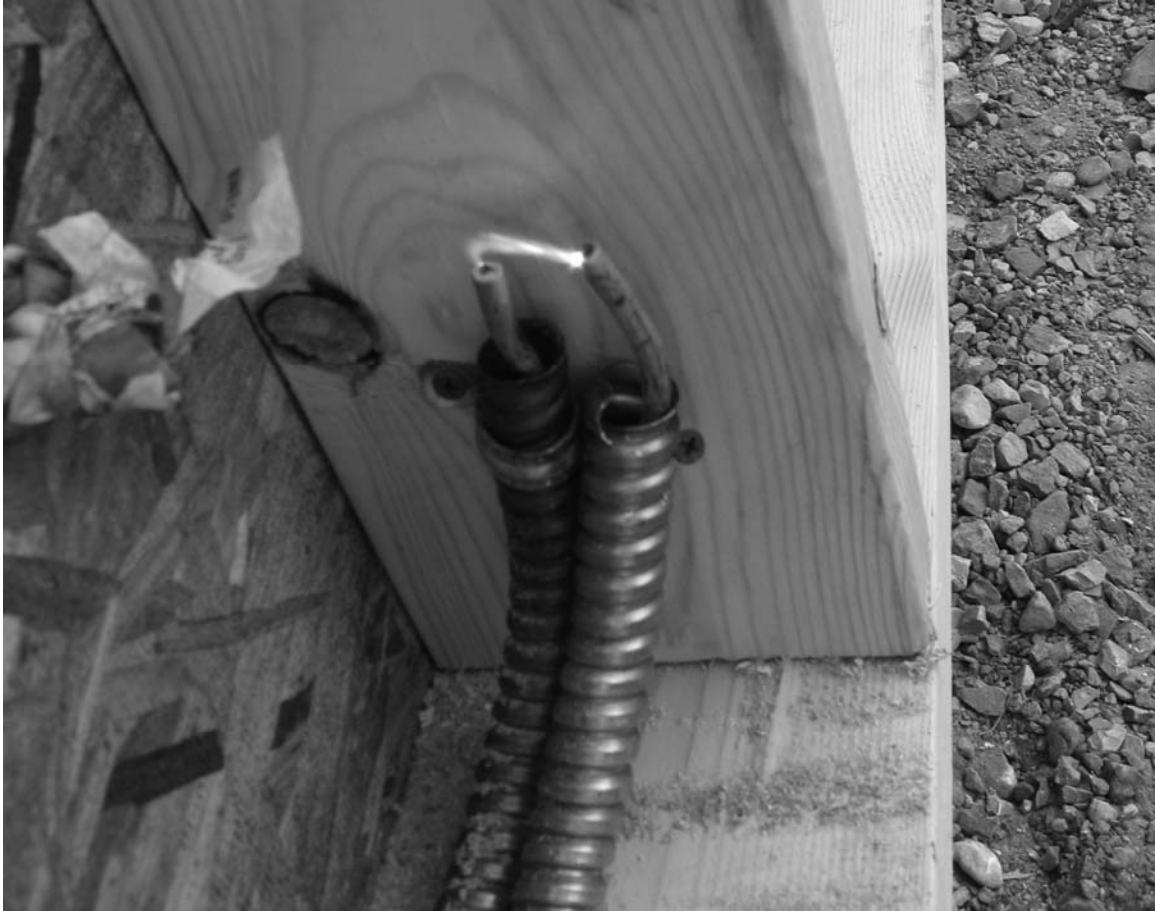
In conjunction with the observations of the potential for multiple arcing opportunities, as noted above, it was observed in early testing that arcs could be initiated through air over substantial distances. It was found, for instance, that a 12,000 volt rated transformer could initiate and sustain an arc between its two GTO output wires over a distance of ¾" without great difficulty (see Figure 7), while a 15,000 volt rated transformer could initiate and sustain an arc in air over a distance of 1". Surprisingly, this far exceeds the commonly accepted 75,000 volts per inch rule of thumb for arcing in air. It is thought that the difference is potentially associated with the shape of the pointed GTO wires compared to arcing between relatively large spherical electrodes believed to have been used in the test configuration for the classic rule of thumb testing.

Figure 7 - Three quarter inch long arc from a 12,000 volt neon transformer

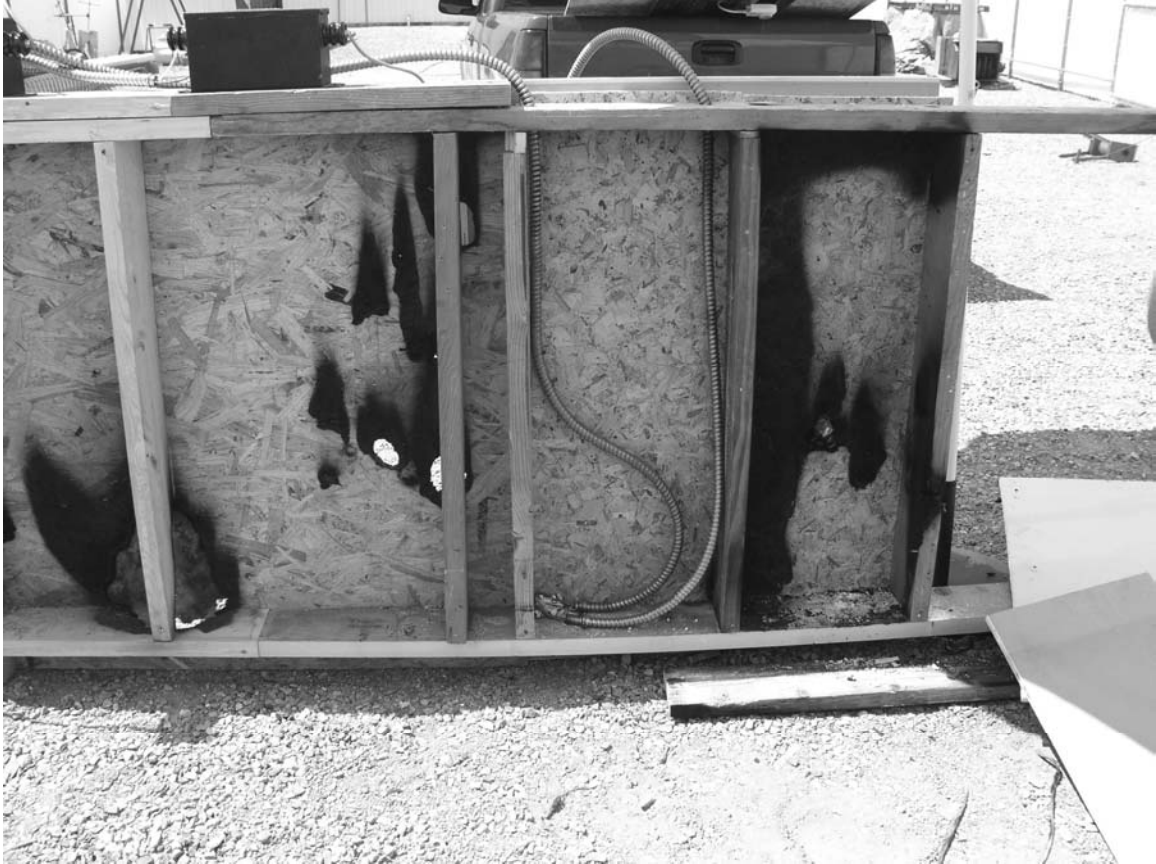
Another characteristic observed during the testing, was that once an arc was struck, the arc length could be extended to a greater length by simply moving the two objects that were arcing away from each other. An interesting aspect of the long arc lengths that these transformers can create is that a greater opportunity exists for a nearby combustible material to be ignited. This is true due to the extended exposure surface area that an ignitable fuel would have in terms of where the fuel would need to be with respect to where the arc is located. It is also of interest that temperatures of 4,000 to 6,000 degrees Fahrenheit within the extended arc would be continued for a long period of time since the low current (30 or 60 mA) arc would not trip the primary circuit breaker that would be supplying power to the transformer nor would the transformer be significantly overheated since it is operating within its designed current delivery rating. In the testing that was conducted, a variety of grounding conditions which resulted in sustained arcs were investigated. These arcs were, in turn, positioned against or close to wood structural components, such as 2" x 6" pine lumber and 7/16" thick OSB. It was found that with sustained exposure of these wood components, particularly for locations where the heat produced by combustion of the wood was relatively contained, the wood would ignite and a sustained fire could be initiated from the output of the neon transformer. Figure 8 shows an example of burning resulting from the tests.

Figure 8 - Neon transformer testing burn patterns

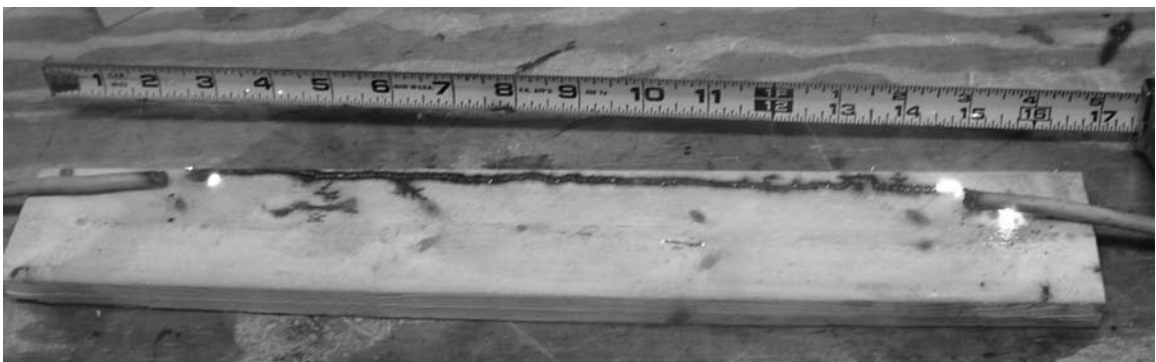
Additional testing on wet wood surfaces indicated that long arc tracks can be produced from the high voltage output of neon transformers. Arc tracks of over one foot were readily created with the exemplar transformers (see Figure 9).

Figure 9 - Arc track on wet wood surface
