NEON TRANSFORMER ELECTRIC ARCS AS VIABLE IGNITION MECHANISMS FOR WOOD STRUCTURAL MEMBERS

Wendell C. Hull, Ph.D. Eng. Sci, CFEI, CVFEI

RESTAURANT FIRE INVOLVING NEON TRANSFORMERS

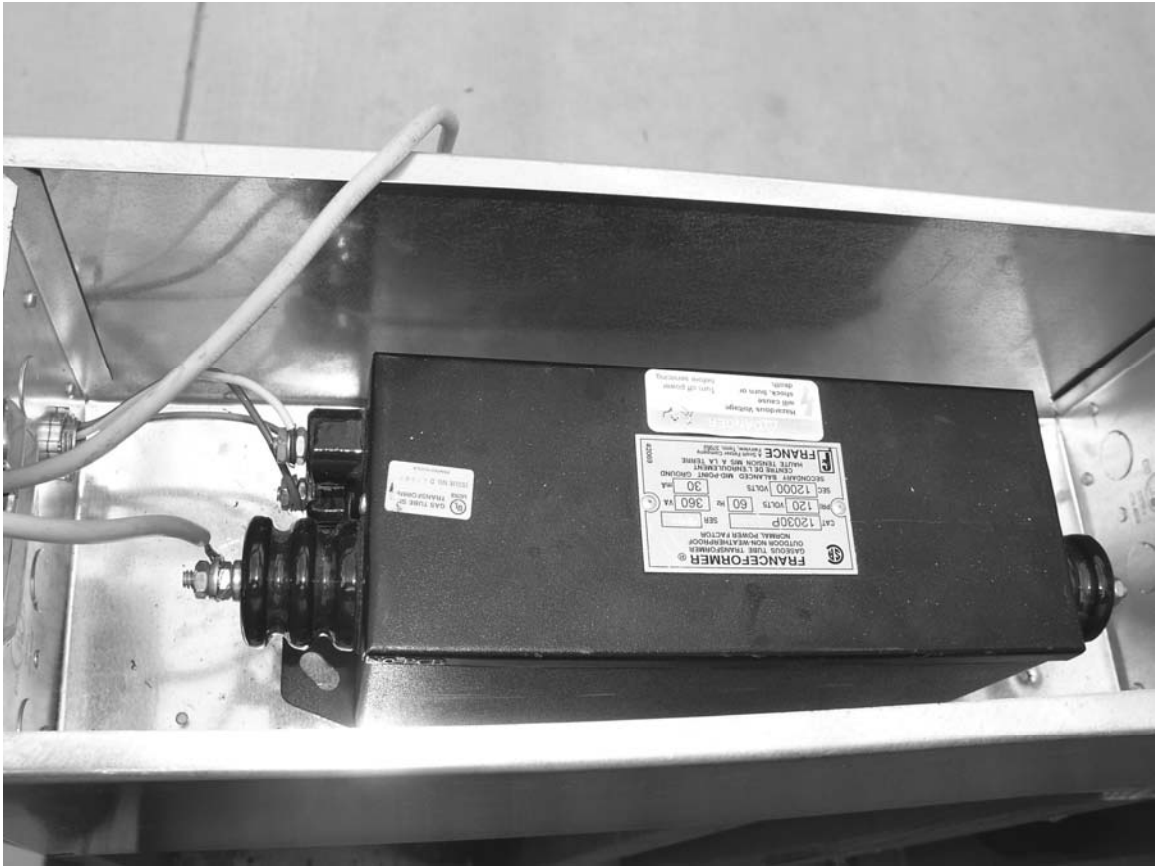
Figure 6 - Non-self contained neon transformer in metal box

The primary 120 volt input to the transformers is boosted to output voltages that range from 3,000 to 15,000 volts. The output current from the transformers are magnetic shunt limited and normally limited to output currents of 30 or 60 milliamperes. This current limiting of the secondary circuit makes it possible to have a sustained short of the secondary circuit for an extended period of time without damage or tripping a primary circuit breaker for transformer models that do not have secondary ground current interruption protection. These transformer configurations, referred to as secondary ground center tap neon transformers, come in both self contained and the non-self contained models. The non-self contained model requires the transformer to be mounted inside a metal box (see Figure 6).
